# DDASaccident817

Humanitarian Demining Accident and Incident Database  
*AID*

# DDAS Accident Report

Deminer Killed by Explosive in Pailin, January 13, 2017

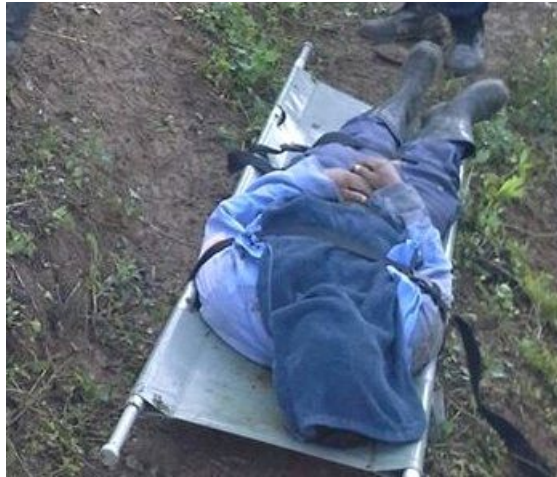
[The picture shows Victim No.1, deceased, after his body armour was removed and a towel has been placed over his head.]

Victim No.1's head is concealed in the photograph but his hands are shown and appear to be uninjured. This implies that he was using a long tool of some kind that may have broken up and caused his injuries. That he suffered a fatal fragmentation injury to his head from a small

blast mine indicates that his blast visor was not worn, or not worn correctly, and (in the absence of other information) implies that his hand tool caused his injury.

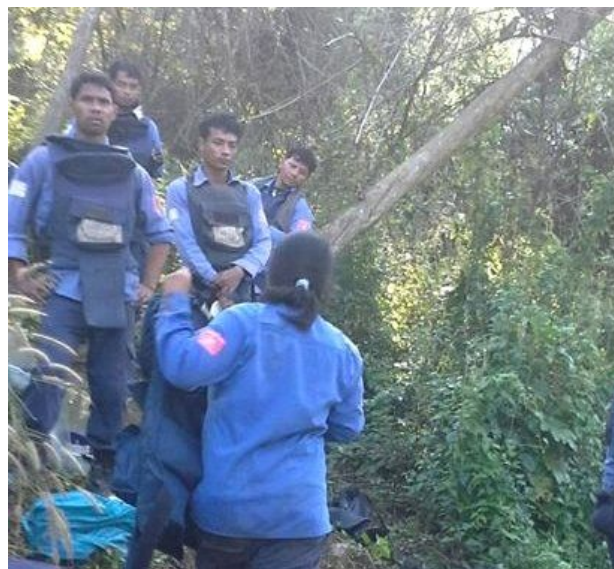
[The picture shows the medic with Victim No.1’s body armour. She is walking up a forested slope with dense undergrowth, typical in that area.]

This demining organisation's body armour is shorter than most and usually does not have a collar to interface with the visor and prevent blast entering beneath the visor. However, in this accident the photograph shows one deminer wearing armour has been fitted with a collar to interface with the visor (which is a welcome improvement) but only on two of the four armours shown.

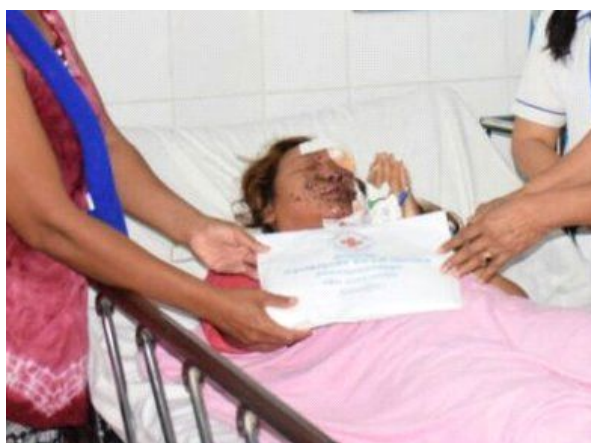
[The picture shows Victim no.2, a “deminer [who] was taken into emergency treatment after an accident during demining”.

Victim No.2's facial injuries shown indicate that either she was not wearing a visor or that the visor was raised. That Victim No.2 also suffered body injuries implies that she either was not wearing her body armour or that it was too small to provide appropriate protection.
